NRL/FR/6180--97-9861

Virtual Environment Firefighting/Ship Familiarization Feasibility Tests

VIRTUAL ENVIRONMENT FIREFIGHTING/SHIP FAMILIARIZATION FEASIBILITY TESTS

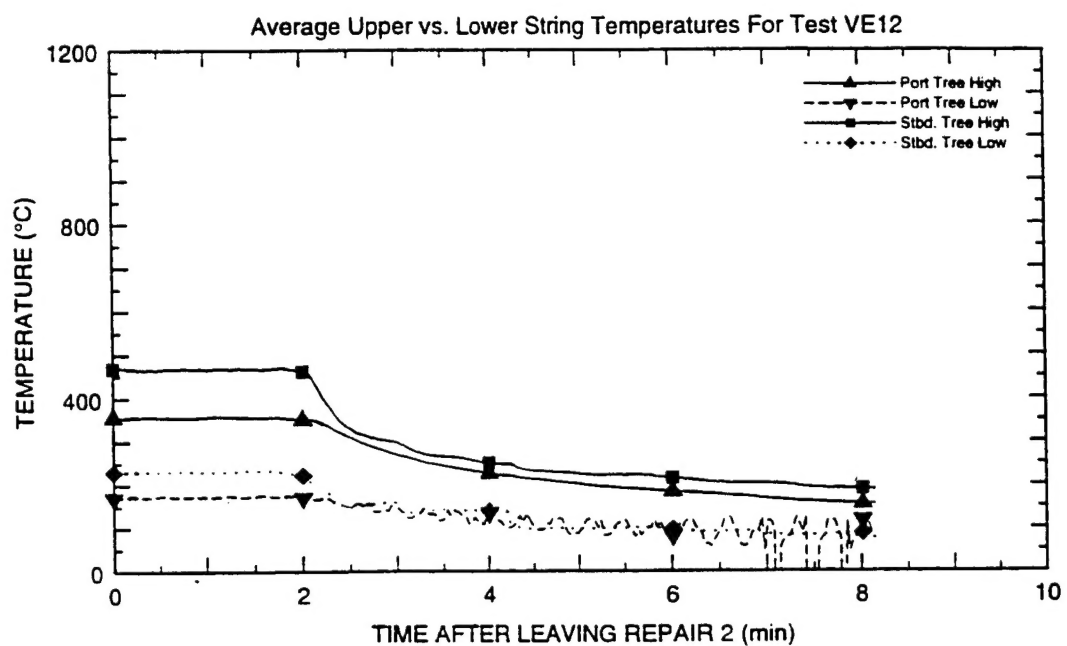
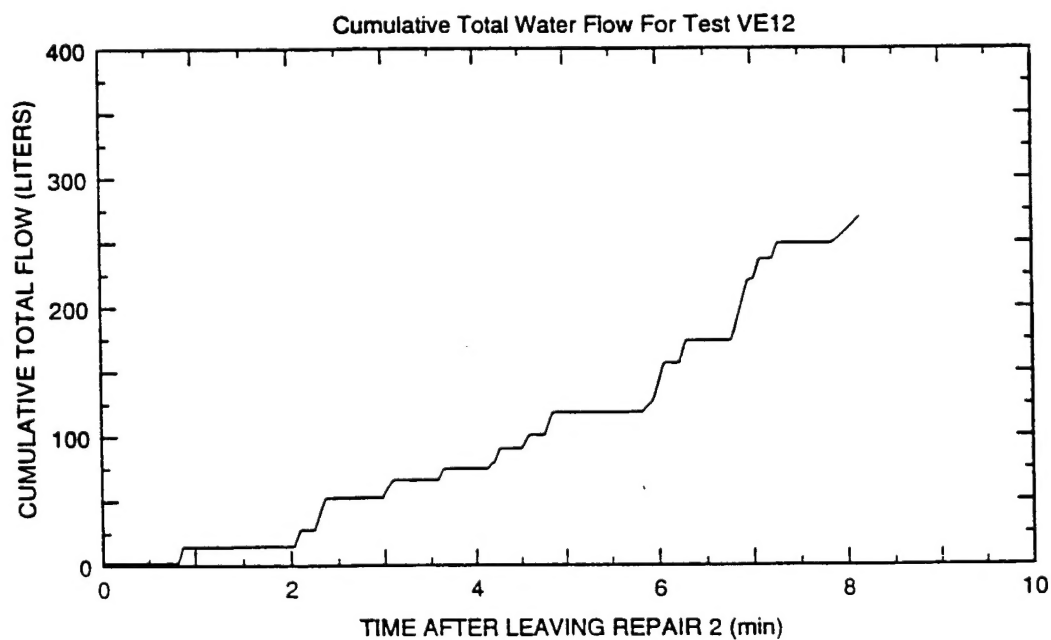
Fig. A24 — Average string temperatures and cumulative total water flow for test VE012
